STROUD TOWNSHIP

MS4 Individual Permit Pollution Reduction Plan (PRP)

March 22, 2019

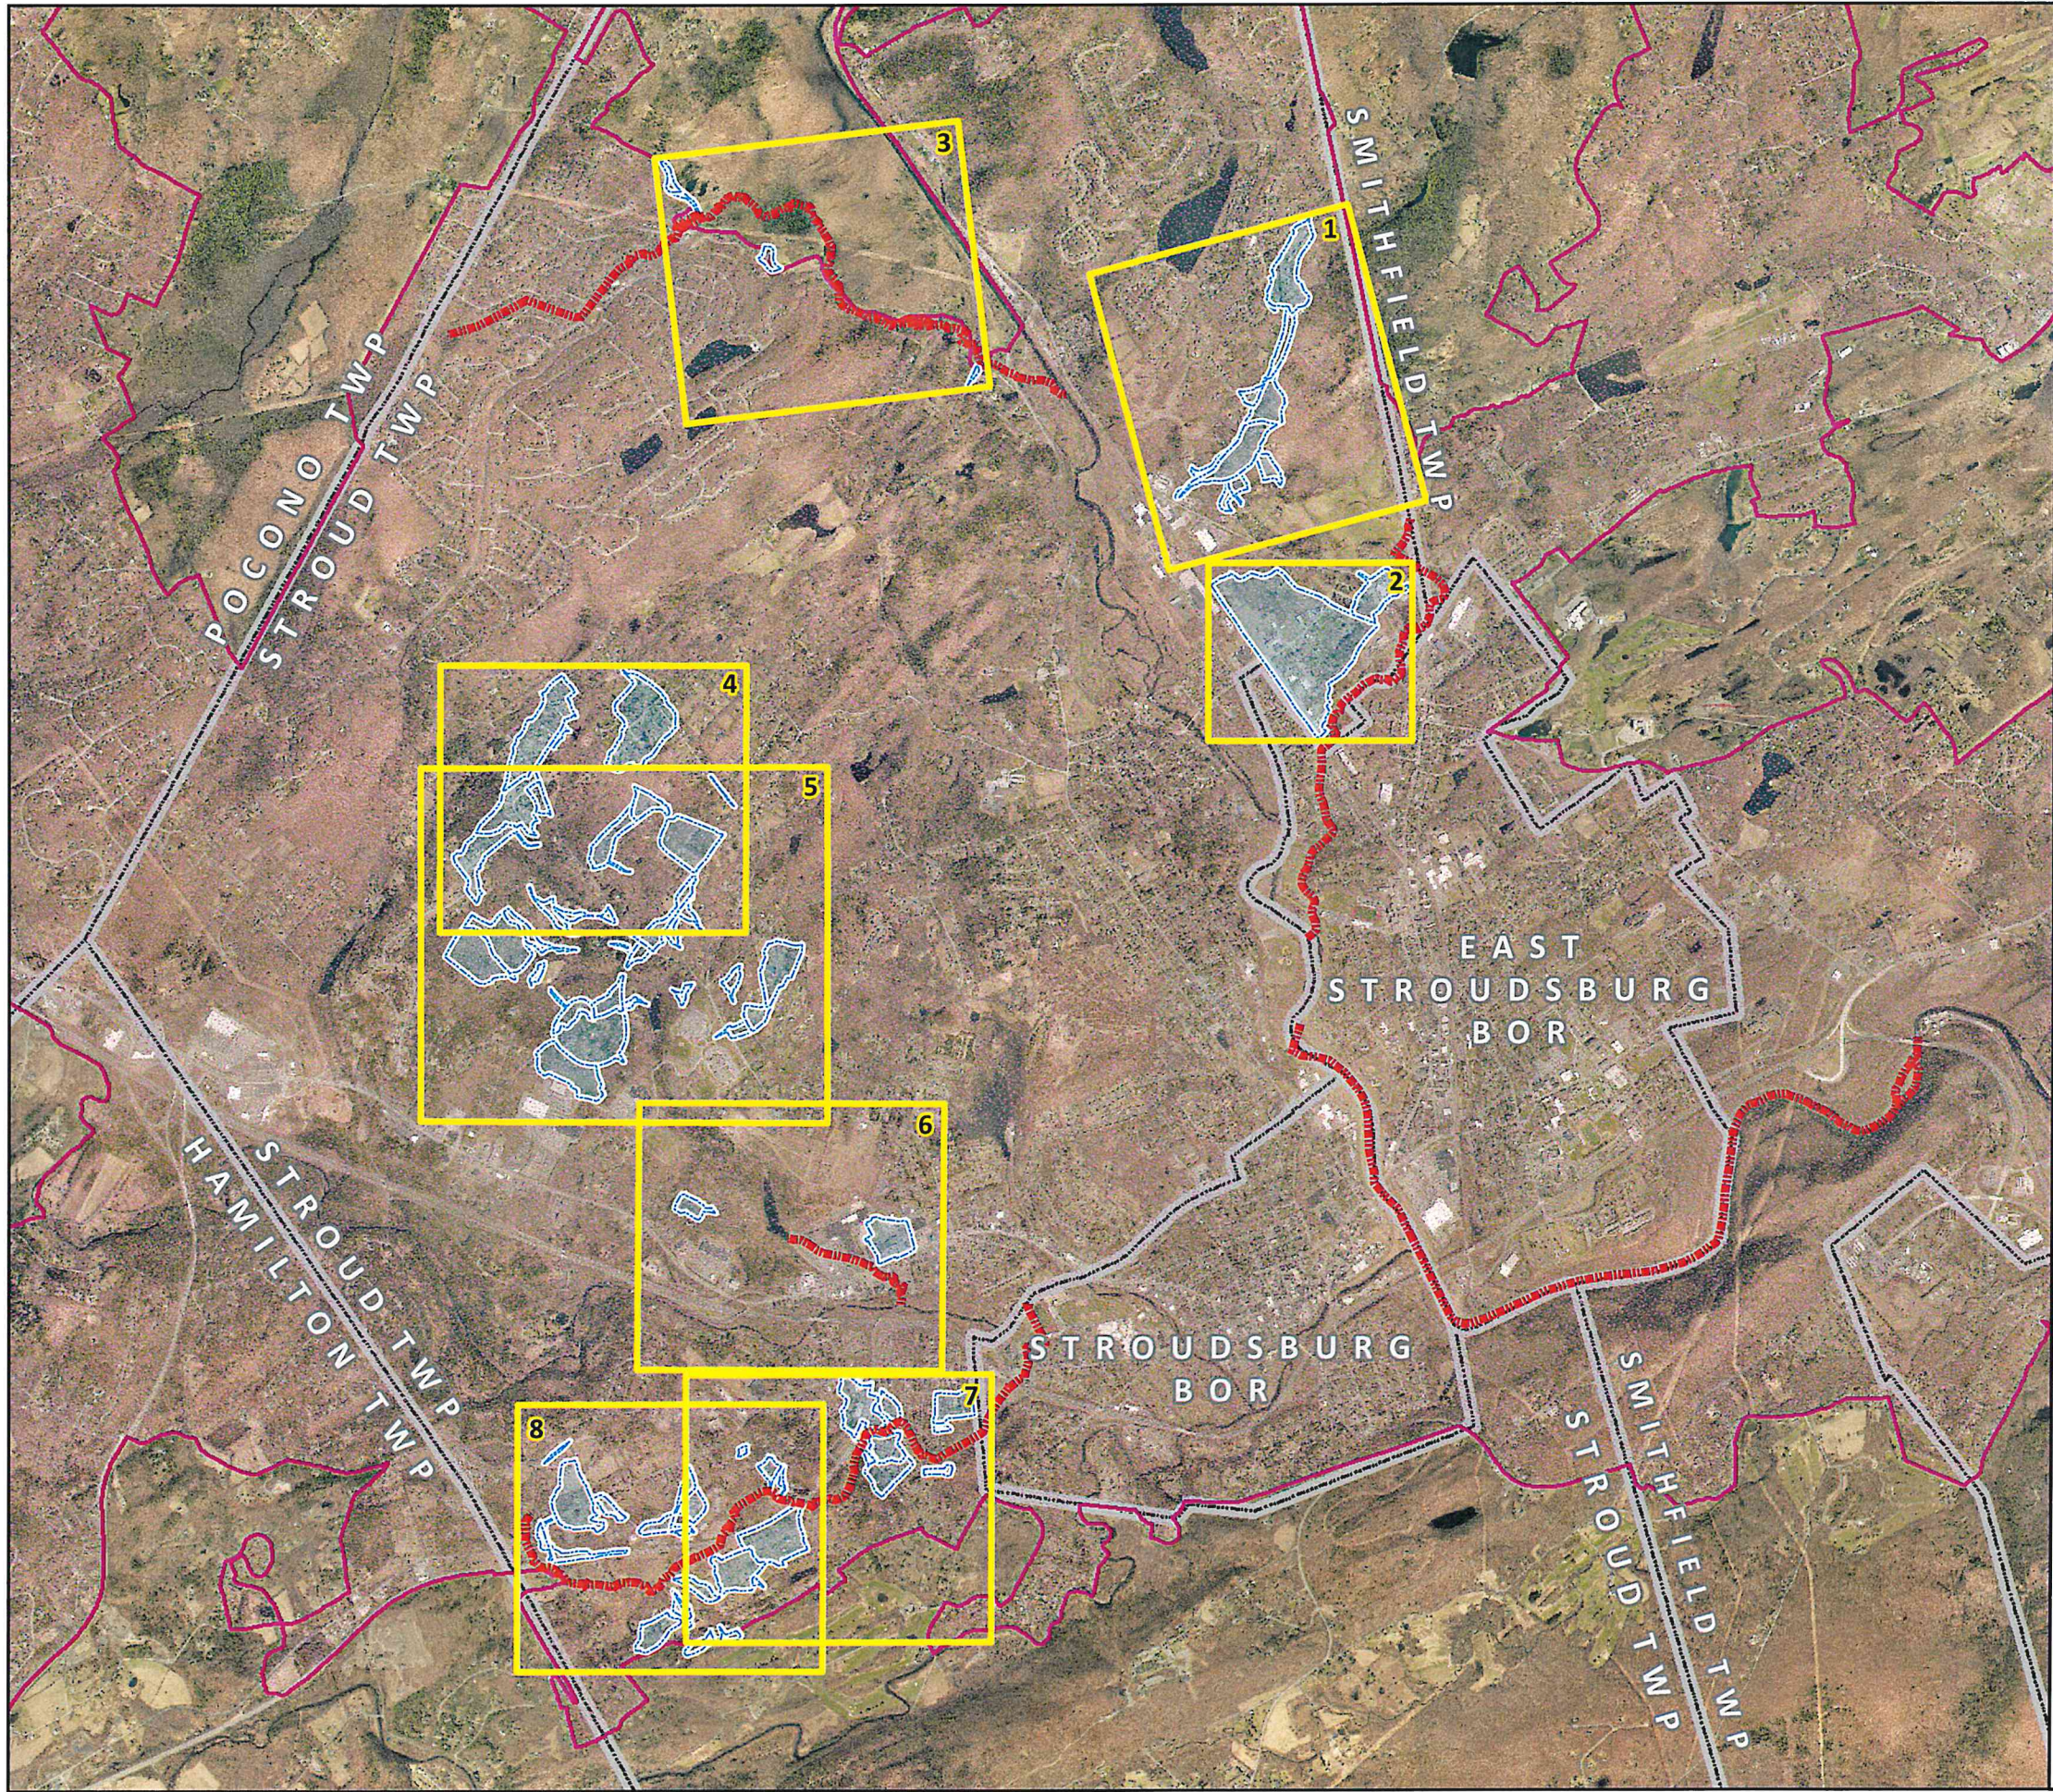
MAP KEY
STROUD TOWNSHIP
MONROE COUNTY, PENNSYLVANIA

MS4 POLLUTION REDUCTION PLAN

PRP maps for the of the Sambo Creek, Flagler Run, Little Pocono Creek and Tributary to the Brodhead Creek are included in Appendix D. The mapping was prepared in conjunction with the Monroe County Planning Commission. Aerial imagery from 2015 is used as the base to show impervious and pervious surfaces. Existing storm water collection and conveyance facilities and BMP's were located and plotted by Stroud Township based on field location and observation and using maps on record with the Township. Storm sewershed boundaries were plotted based on topographic mapping and field confirmation. Locations of potential BMP's are shown on the maps.

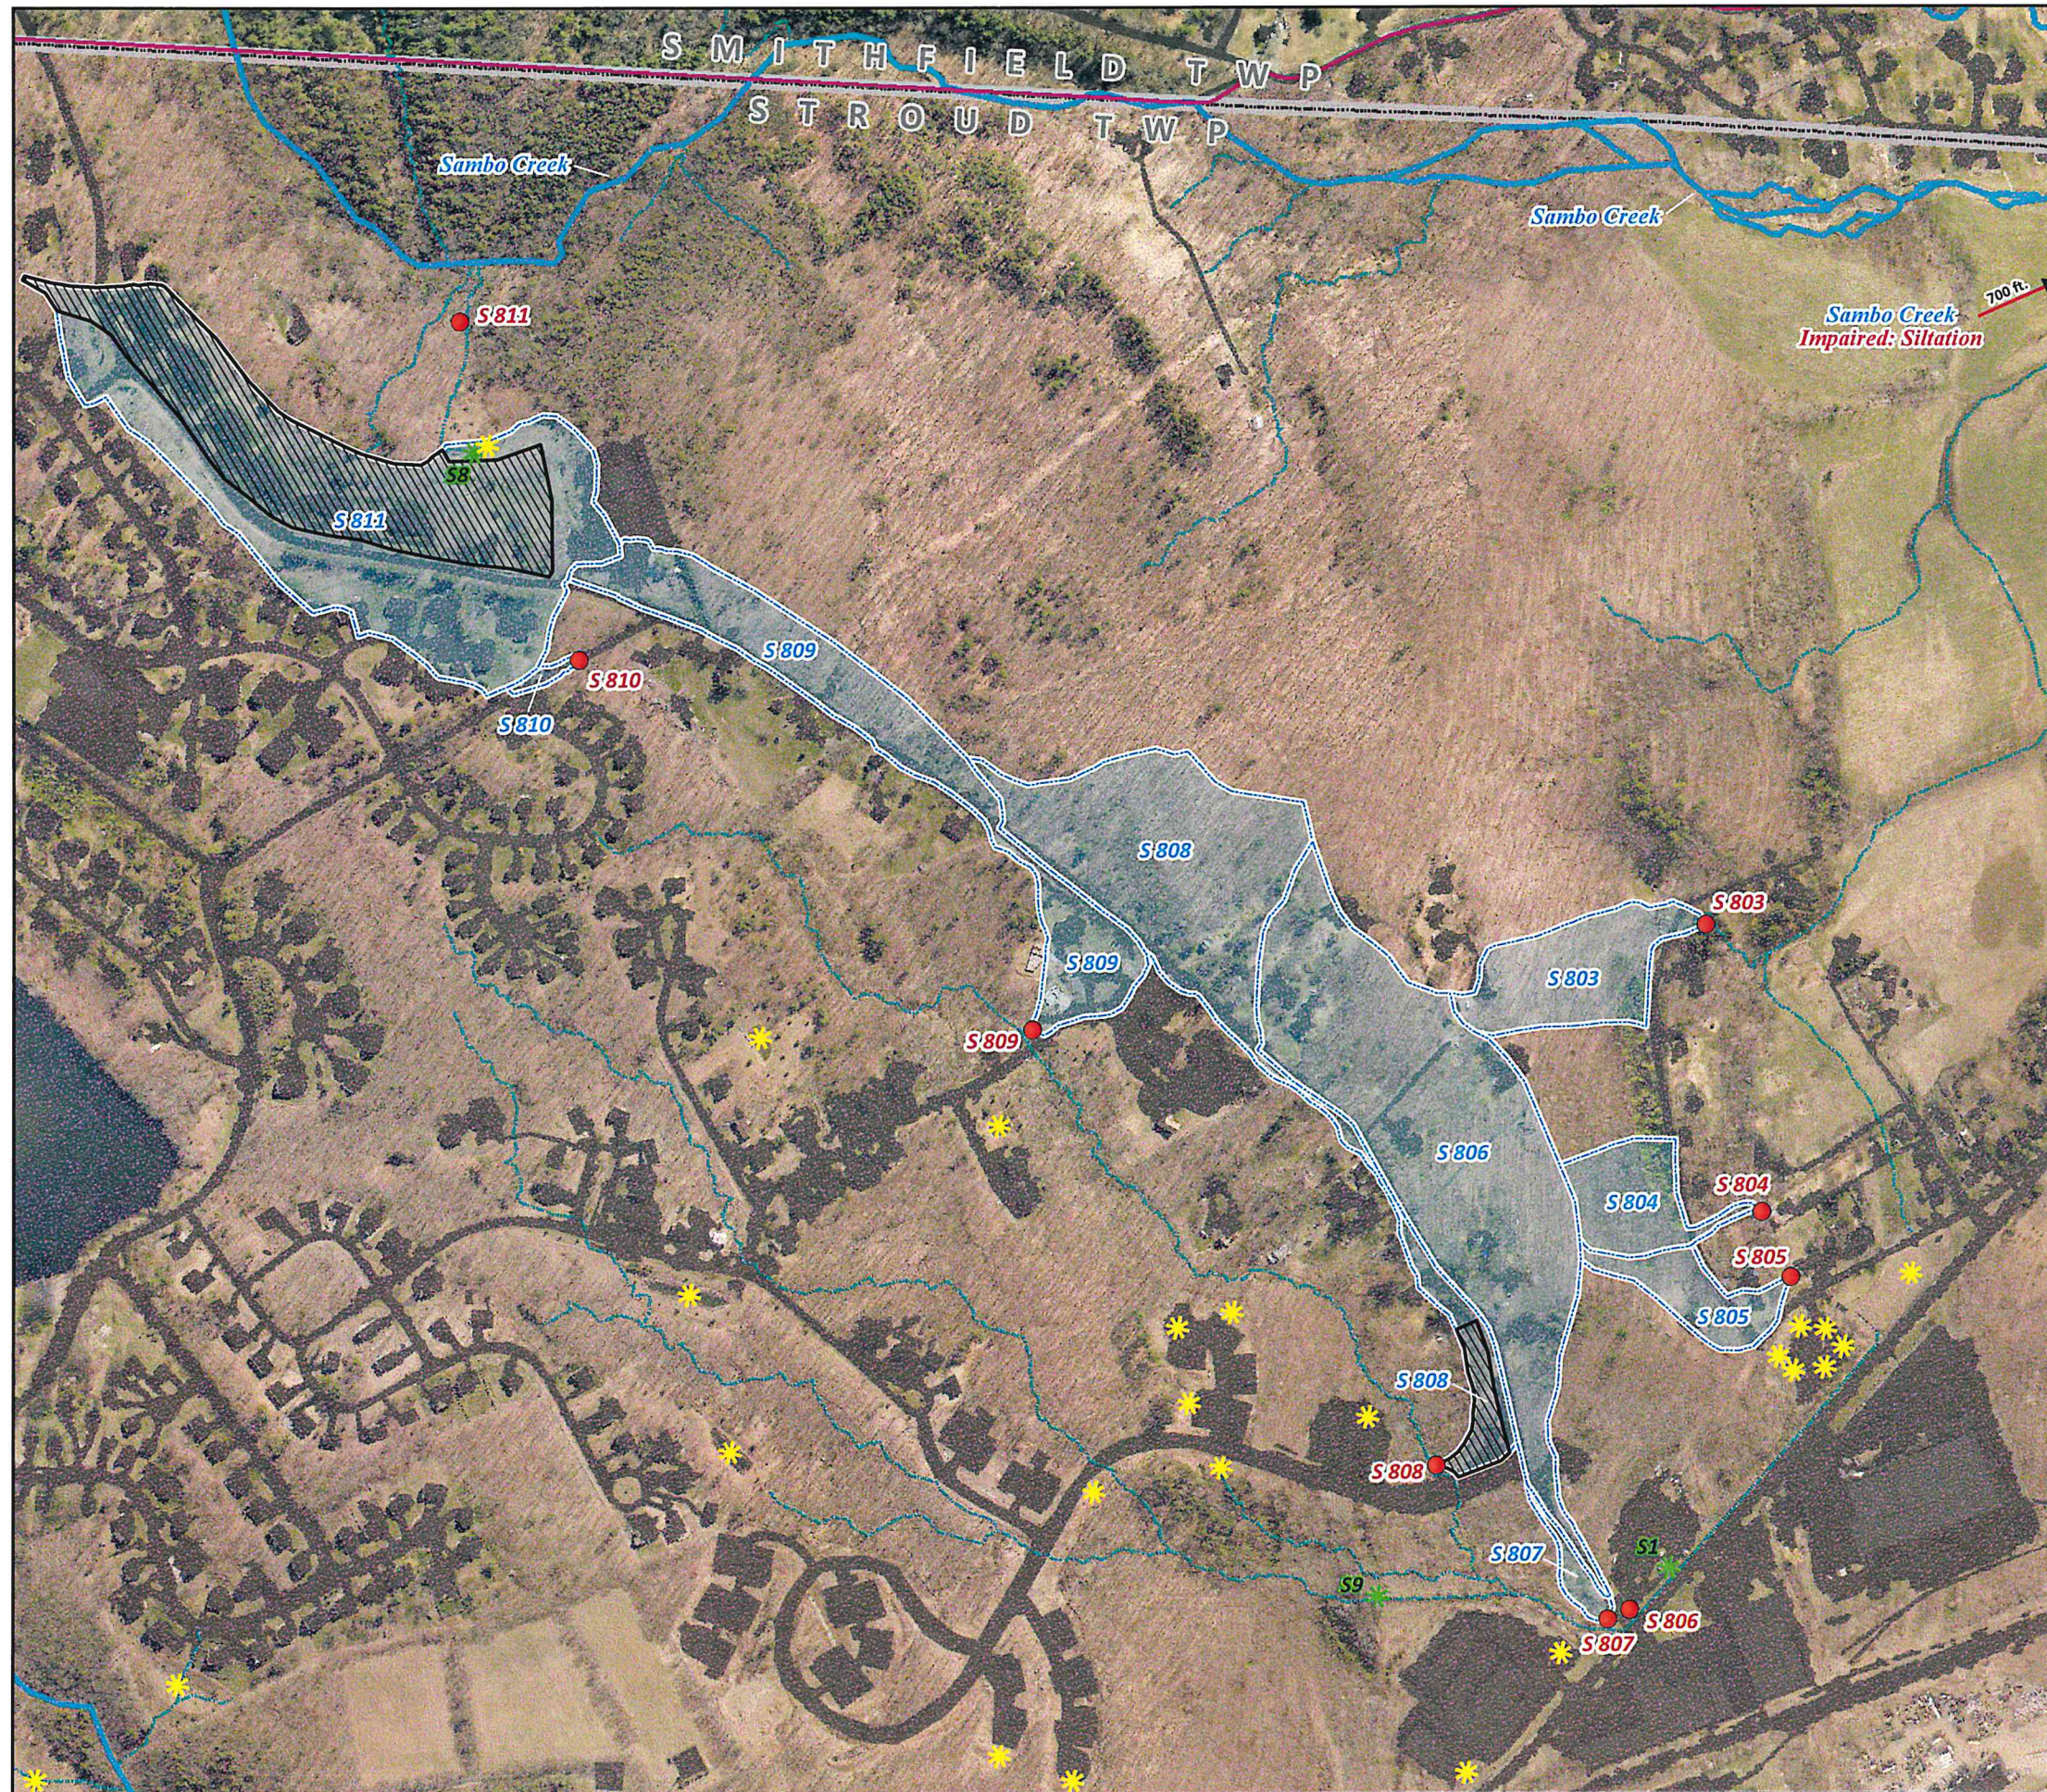
MAP 1 STROUD TOWNSHIP MONROE COUNTY, PENNSYLVANIA

MS4 POLLUTION REDUCTION PLAN

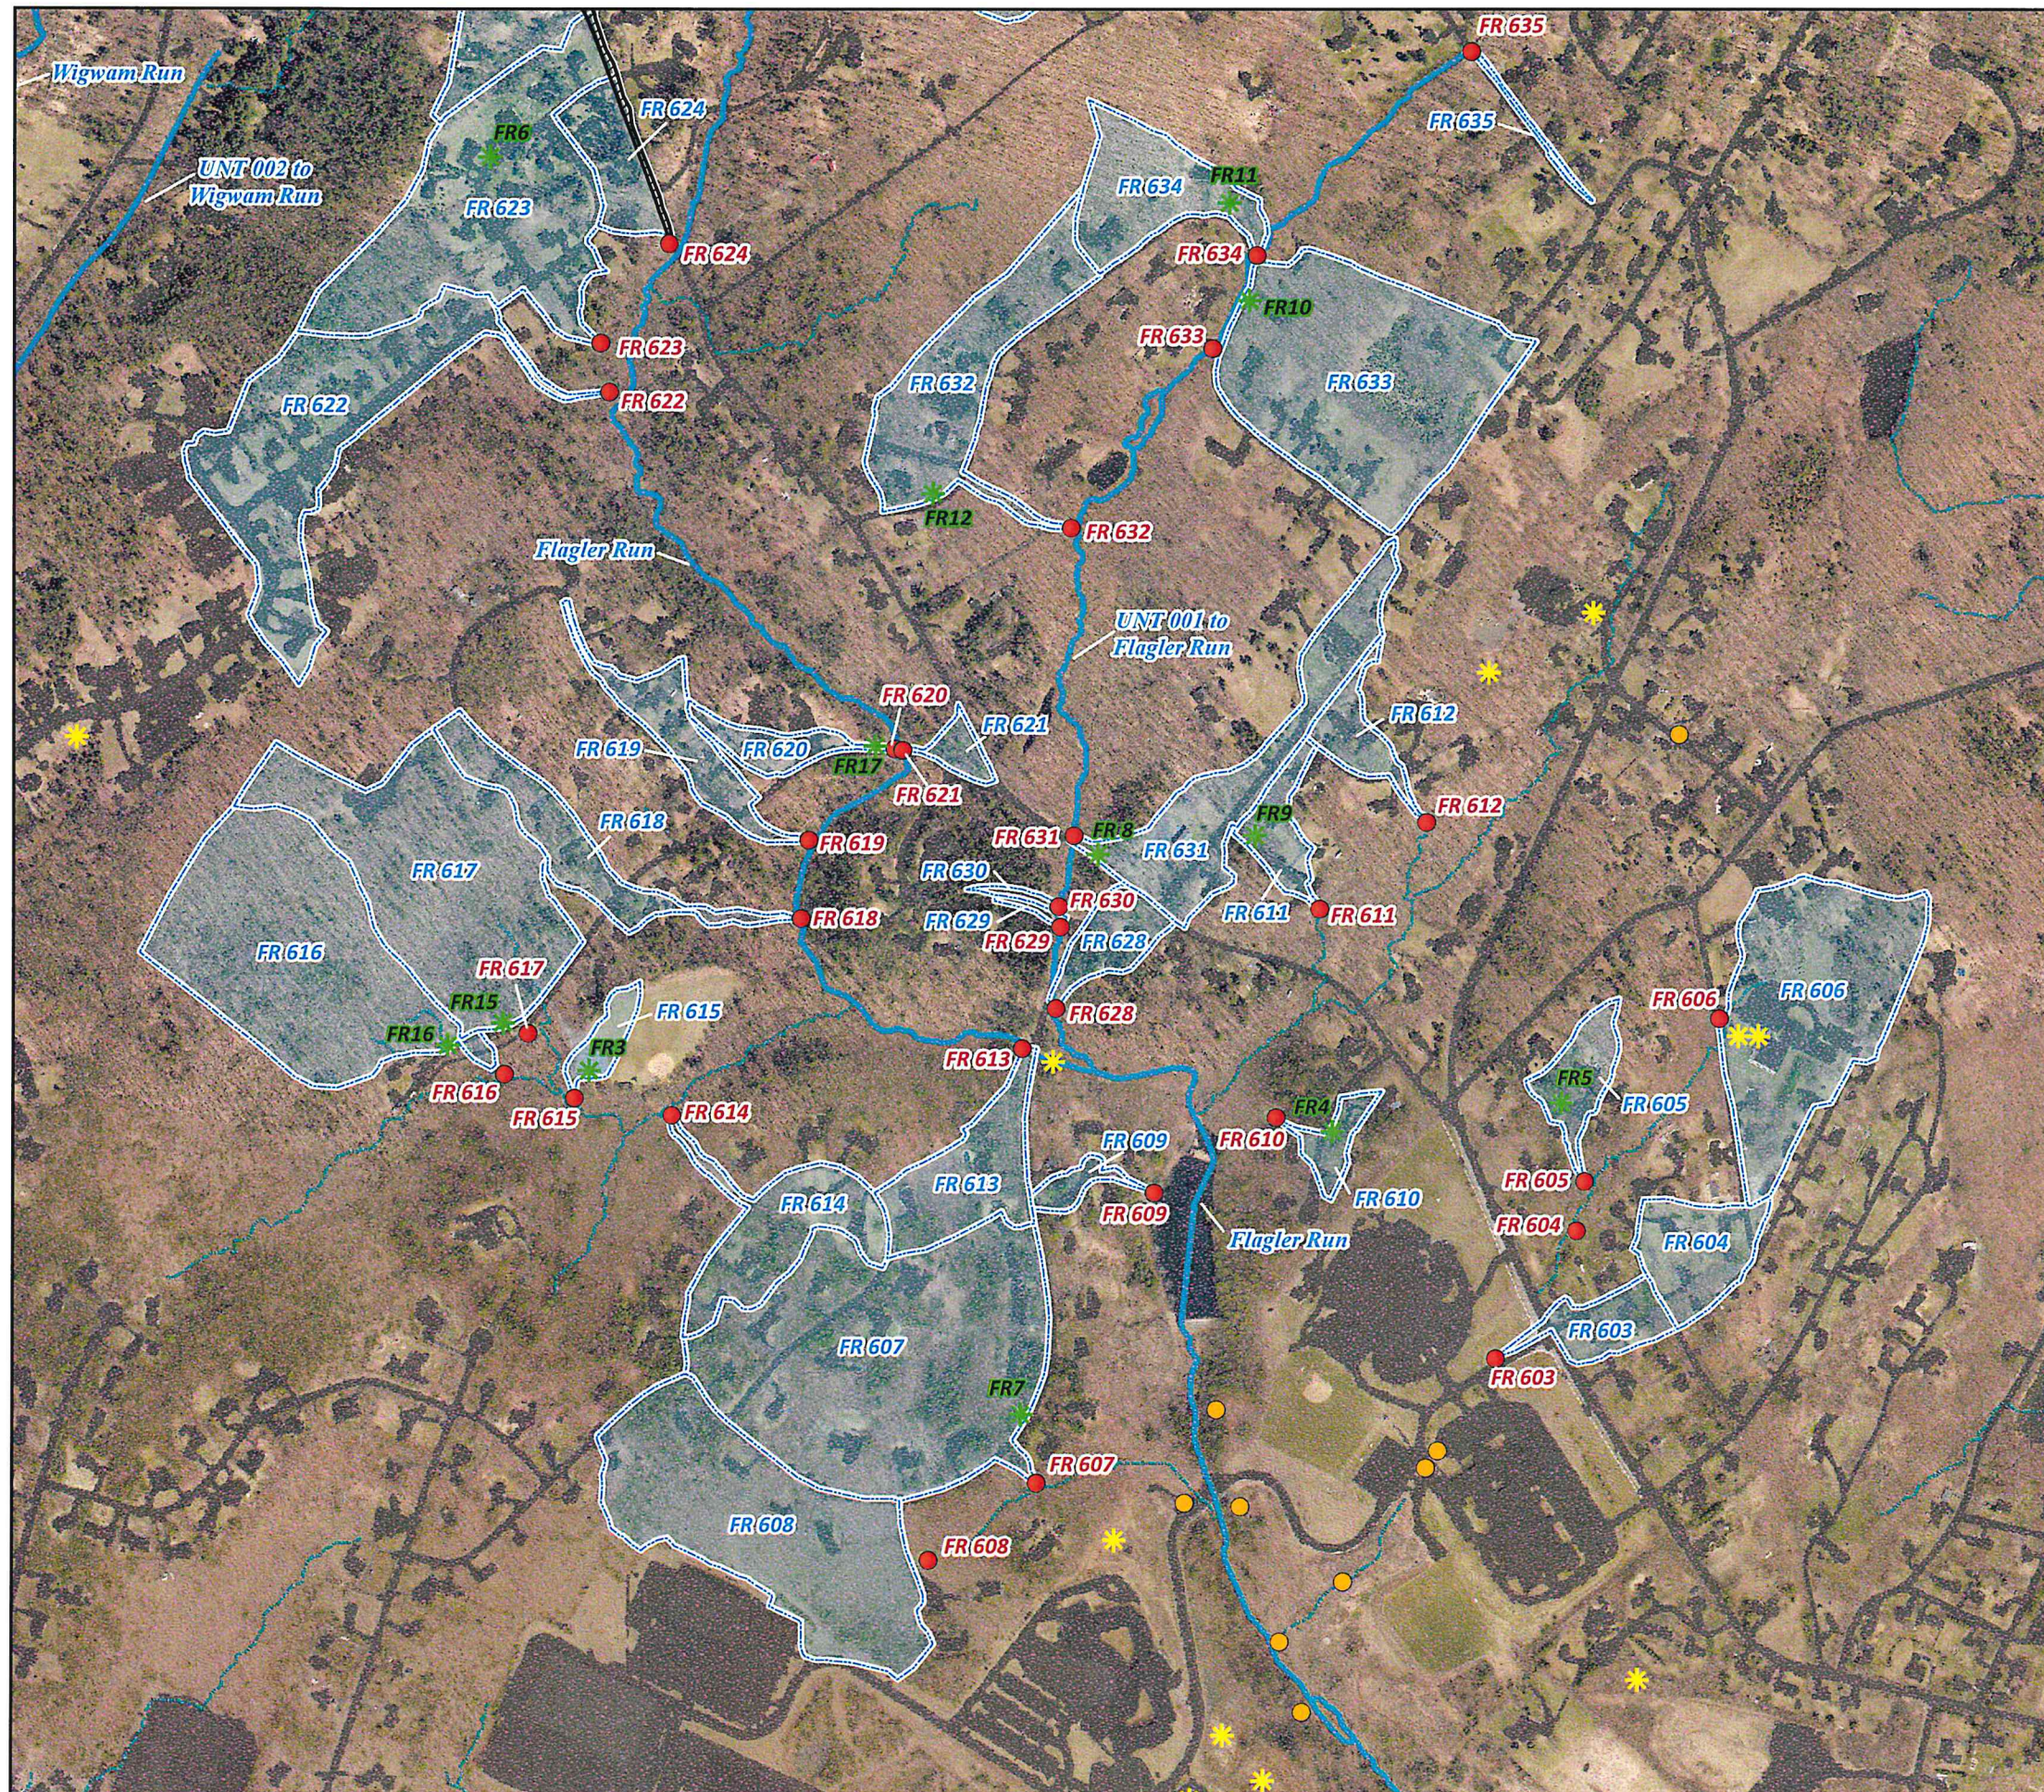
MAP 5

MS4 POLLUTION REDUCTION PLAN

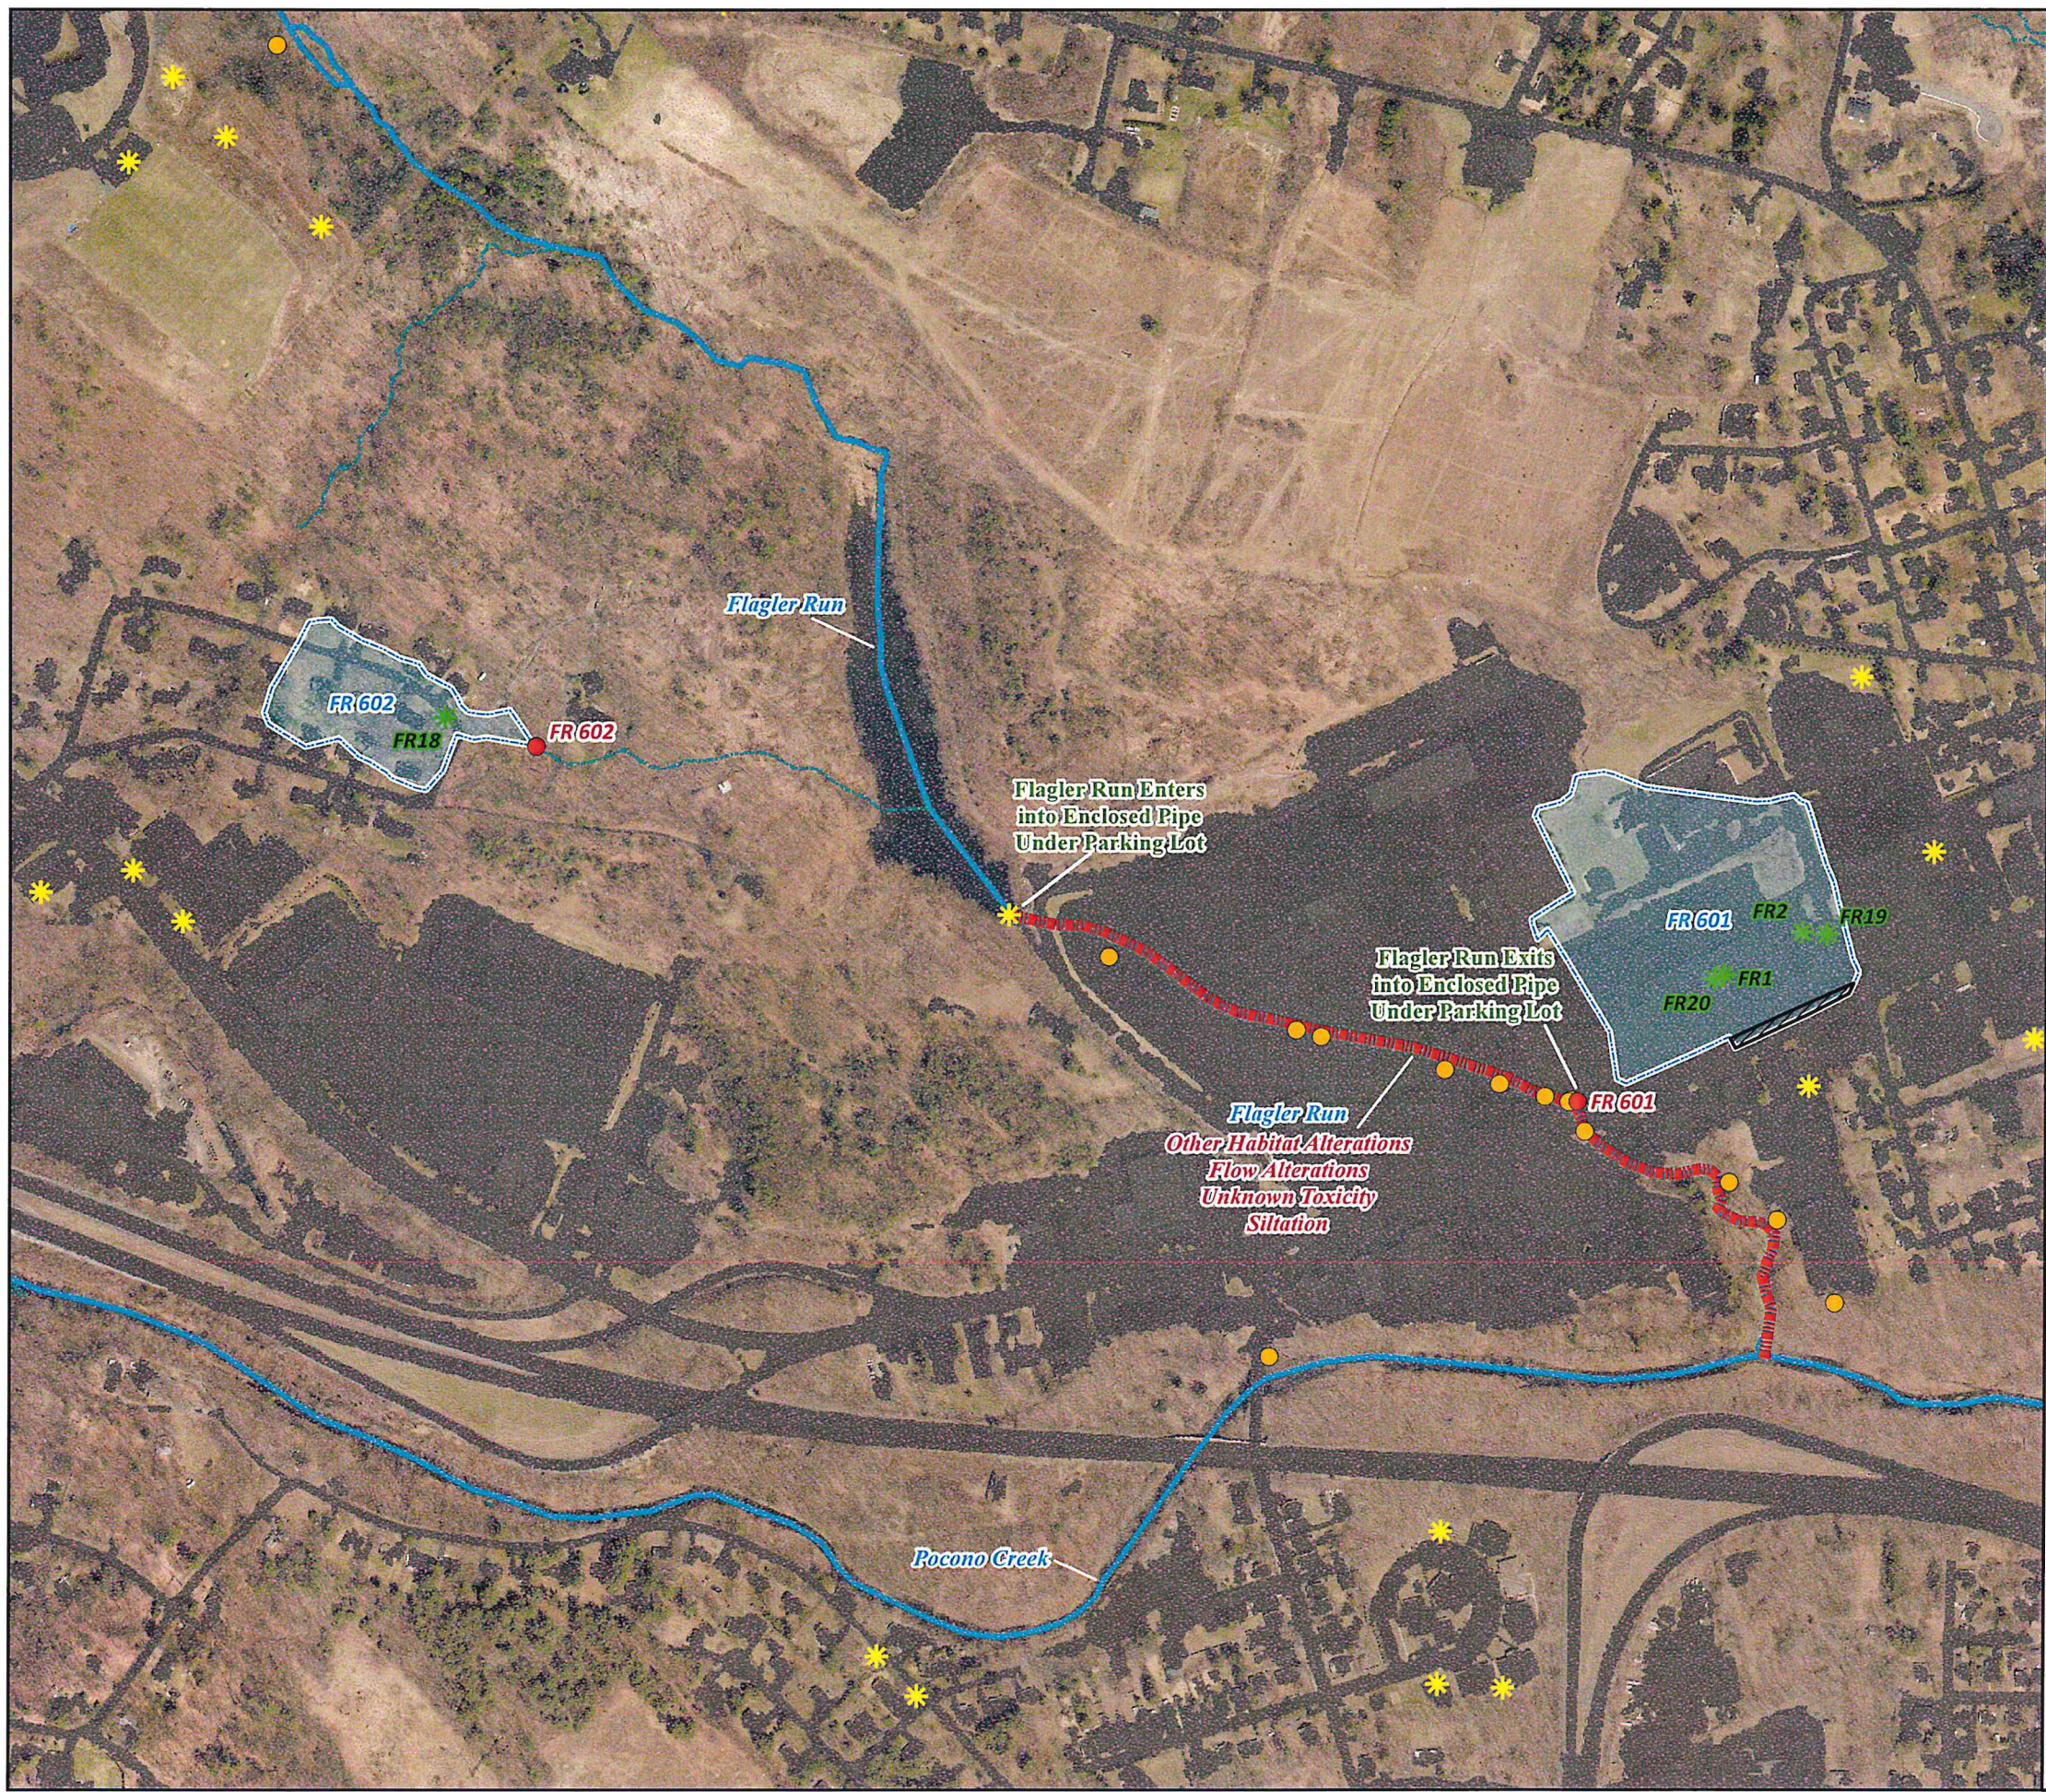
MAP 7 STROUD TOWNSHIP MONROE COUNTY, PENNSYLVANIA

MS4 POLLUTION REDUCTION PLAN
